# DAMASCUS HIGH SCHOOL

## Grounds Management Report

Prepared for the DHS PTSA  
Campus Beautification Committee  
By Stephen Van Hoven  
August 2018

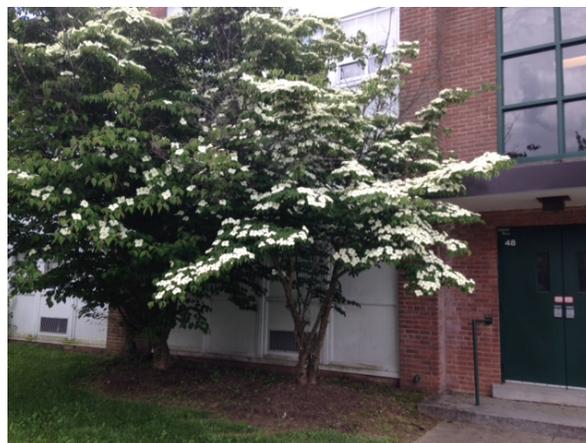
1. The grove of 4 American Hop Hornbeam, *Ostrya virginiana*, just to the south of the gymnasium entrance (trees #92-95). These are great examples of a native landscape tree that is not very common.
2. Tree #87. Common persimmon, *Diospyros virginiana*, another Maryland native. The wood was used to make golf clubs, 'woods'. The wood is very hard, persimmon is in the ebony family. Produces edible fruit.
3. Trees #54, 56, 74 and 75. Very nice specimens of the Kousa dogwood, *Cornus kousa*. Native to China, blooms after the native flowering dogwood.

Kousa dogwood, *Kousa dogwood*

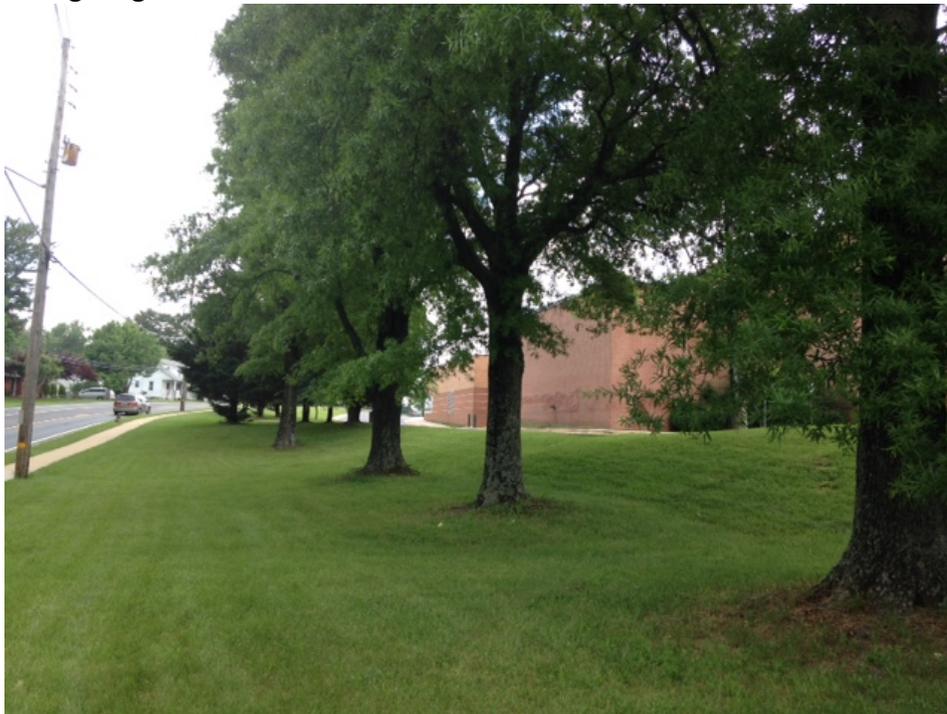
7. Trees #41-44. These 4 Willow oaks, *Quercus phellos*, are the largest on campus and line the side walk along Ridge Road.

Willow oaks, *Quercus phellos*

SPECIES	COMMON NAME	EST. DBH	CONDITION	Maintenance	Notes
1	Tilia cordata	Littleleaf linden	12	VG	Crown Raising	
2	Tilia cordata	Littleleaf linden	12	VG	Crown Raising	
4	Robinia pseudoacacia	Black locust	12	F	Prune	
5	Ulmus parviflora	Lacebark elm	4	P	Removal	
6	Ulmus parviflora	Lacebark elm	5	P	Removal	
7	Ulmus spp.	Elm	8	F	Prune	
8	Ulmus spp.	Elm	10	F	Prune	
9	Quercus palustris	Pin oak	20	G	Prune	
11	Gleditsia triacanthus var. inermis	Honeylocust	8	G	Prune	
12	Gleditsia triacanthus var. inermis	Honeylocust	6	P	Removal	
13	Quercus palustris	Pin oak	8	F	Prune	
14	Quercus palustris	Pin oak	9	P	Removal	
15	Prunus cerasifera 'Atropurpea'	Cherry plum	3	P	Removal	
16	Prunus cerasifera 'Atropurpea'	Cherry plum	3	P	Removal	
17	Quercus palustris	Pin oak	8	P	Removal	oak galls
18	Quercus palustris	Pin oak	10	F	Prune	
19	Acer rubrum	Red maple	2	P	Removal	remove- too close to stop sign
41	Quercus phellos	Willow oak	24+	G	Crown Raise/ Prune

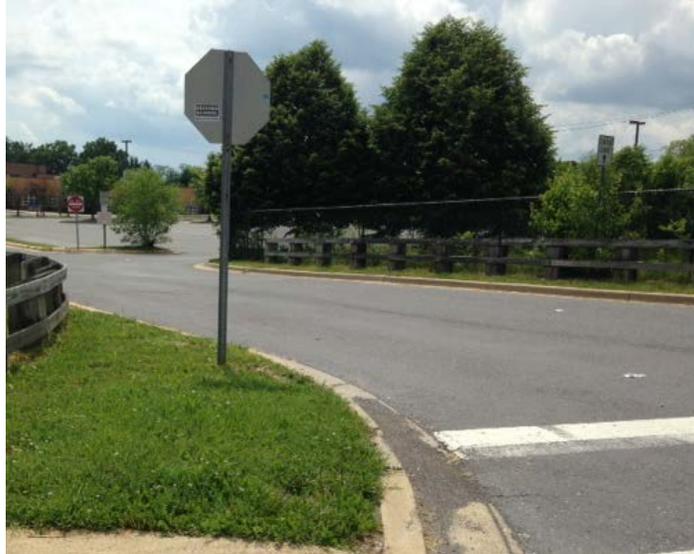
8. Trees #1 and 2. These two littleleaf lindens, *Tilia cordata*, are excellent specimens. They are growing inside the fenced off storm water management area. The weeds along the fence block the view of these trees, which will greatly enhance the parking area when pruned and made visible, they will create a nice focal point at the entrance off Bethesda Church Road.

Two littleleaf linden, *Tilia cordata*

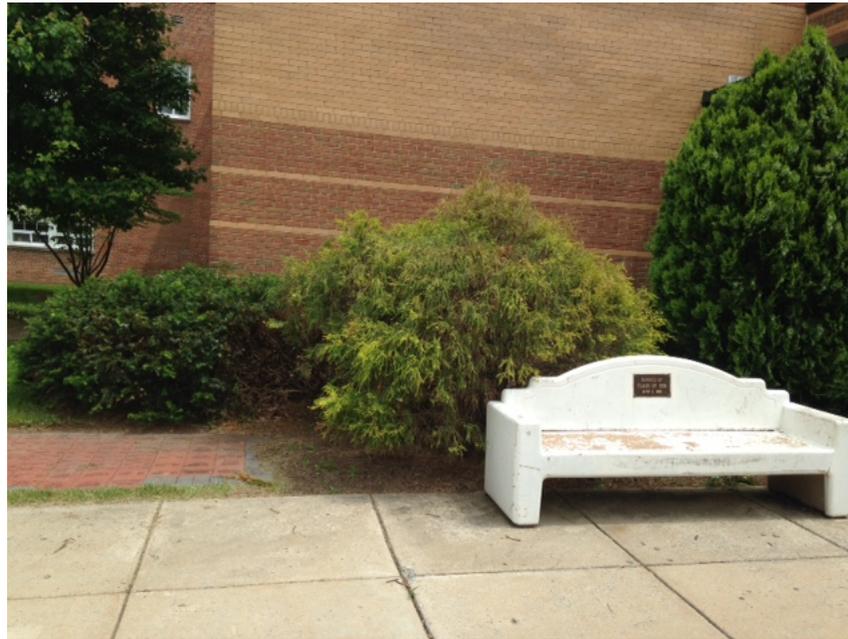
1. The class of 1996 bench. Located to the north of the main entrance to the school.

2. The donated bricks located to the north of the main entrance to the school.

Donated bricks and Class of 1996 bench located to the north of the main entrance.

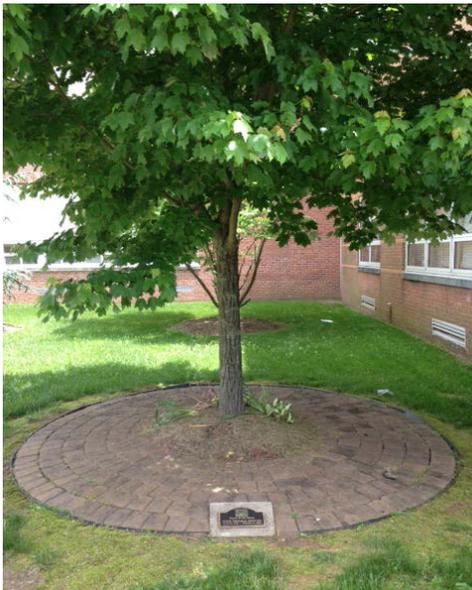
3. The Ryan Thomas Didone Memorial Tree. Tree #57 is a red maple, *Acer rubrum*. The memorial also includes a nice brick tree ring and plaque.

Ryan Thomas Didone Memorial Tree

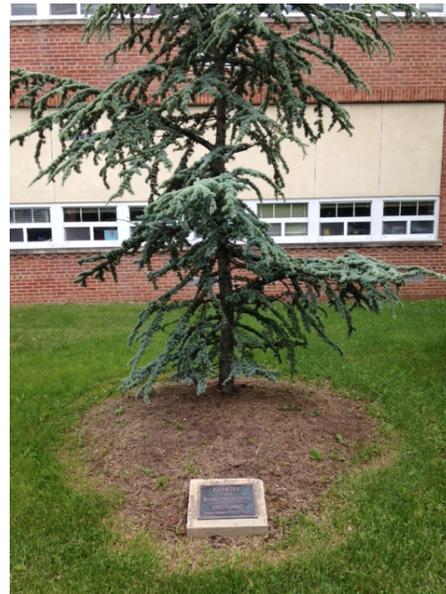
Ezekial Oak Babendrier Memorial Tree

4. Ezekial Oak Babendrier Memorial Tree. Tree #55 is a Blue Atlas Cedar, *Cedrus atlantica*. There is a plaque at the tree.

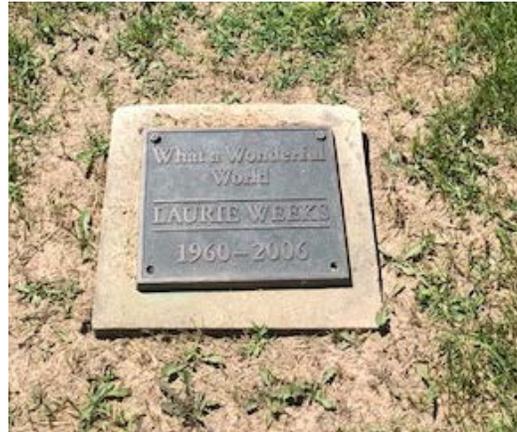
5. Laurie Weeks Memorial plaque. There is a plaque located near the bus stop along Ridge Road. It is assumed that there was a tree planted there as well that has been removed.

Laurie Weeks Memorial

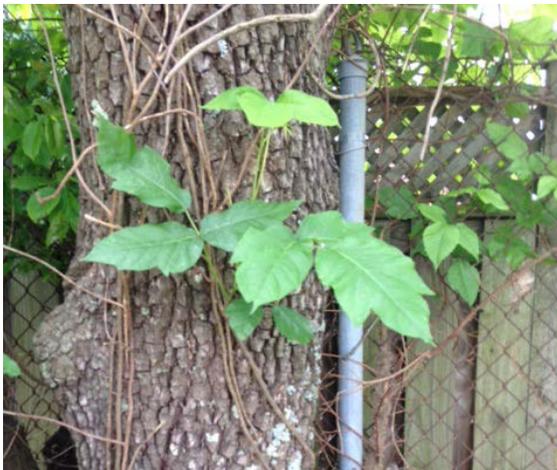
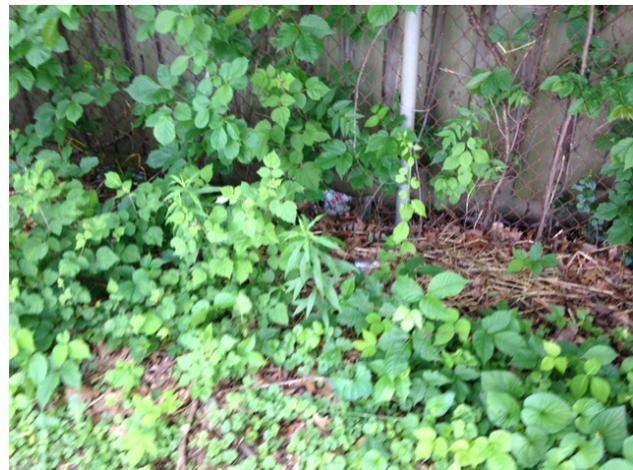
**Poison Ivy.** There are several areas around the campus where poison ivy is extensive and in close proximity to sidewalks, parking lots or buildings where students or staff can be exposed.

Poison Ivy growing at the south end of the staff parking lot along the southern boundary fence.

At a minimum, the vines should be cut at the base to kill the upper part of the vine. The ivy will grow back unless the roots are removed or treated with herbicide. Poison Ivy growing on the ground should be sprayed with herbicide.

9. Remove poison ivy from areas.

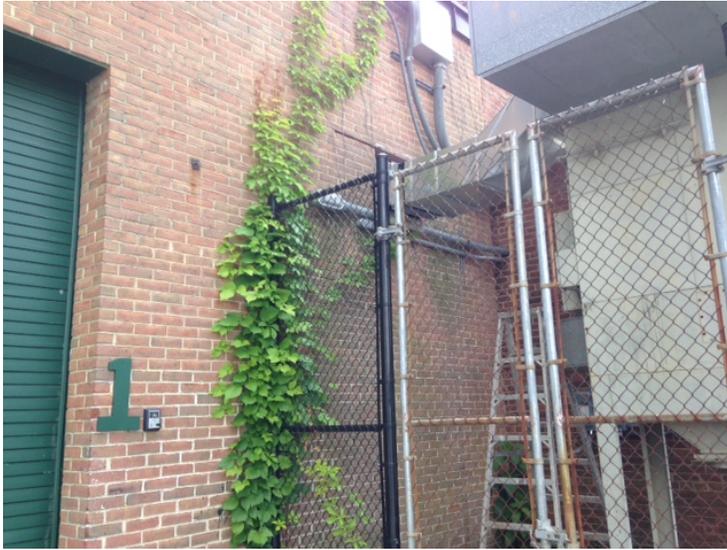
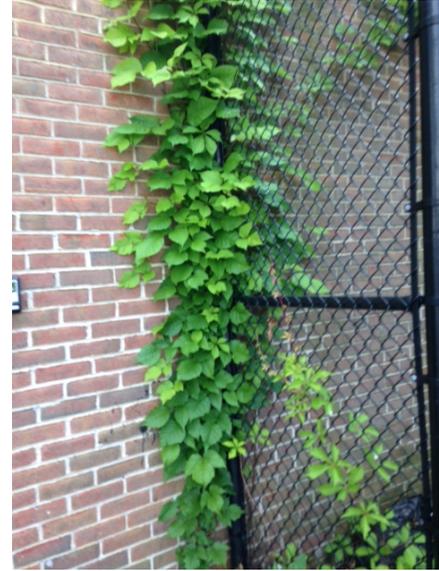
Poison Ivy growing on building and fence on northside of campus.

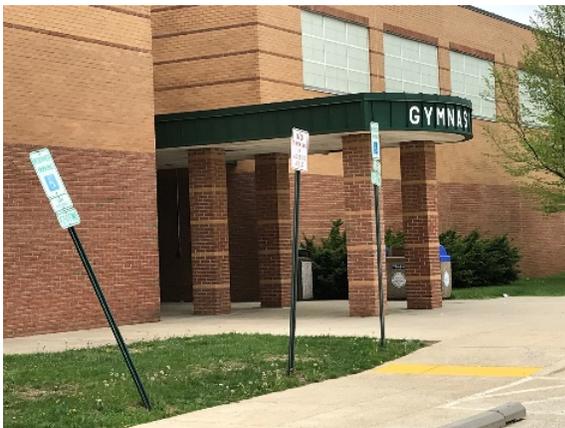
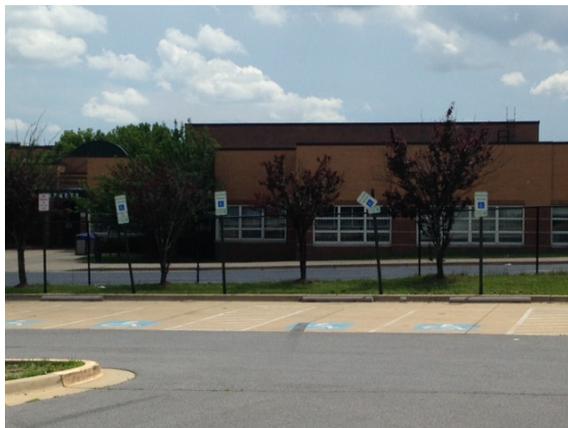
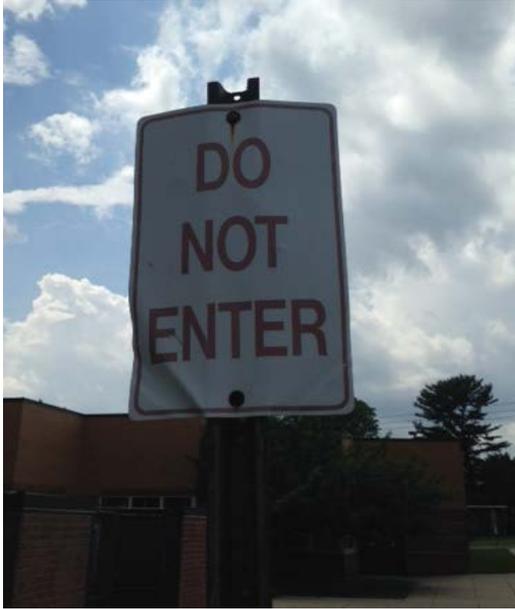
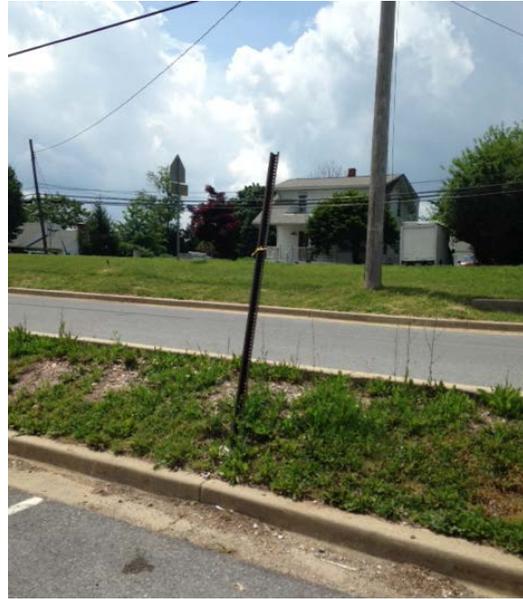
***Crooked, broken, missing and damaged signs.*** There are several signs on the campus and in the parking areas that are leaning, crooked, bent or missing. Visually, these signs are very noticeable, especially at the main entrances to the school. In addition, several signs appear very old and faded. Bent, rusty and unsightly signage should be replaced in order better the appearance of the grounds. Signs should be checked that they meet minimum standards for height, legibility and retroreflectivity. Refer to the Maryland State Highway Administration Manual on Uniform Traffic Control Devices 2011 (Parts 2A.07, 2A.21, 2A.22).

Empty, bent sign post

5. Fix crooked, bent signs. Remove blank sign posts. If possible, replace broken, faded, or bent signs.

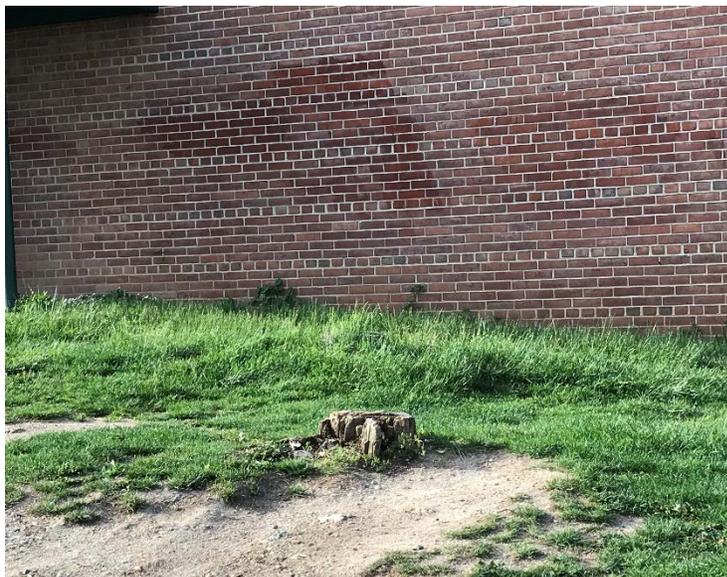
**Stumps.** There are several stumps left throughout the grounds. In addition to being unsightly, they prevent the possibility of replacing trees, especially when the stumps are left in the parking lot islands as there is limited space. Stumps left in high pedestrian traffic area can also present a tripping hazard.

7. Grind or remove existing stumps.

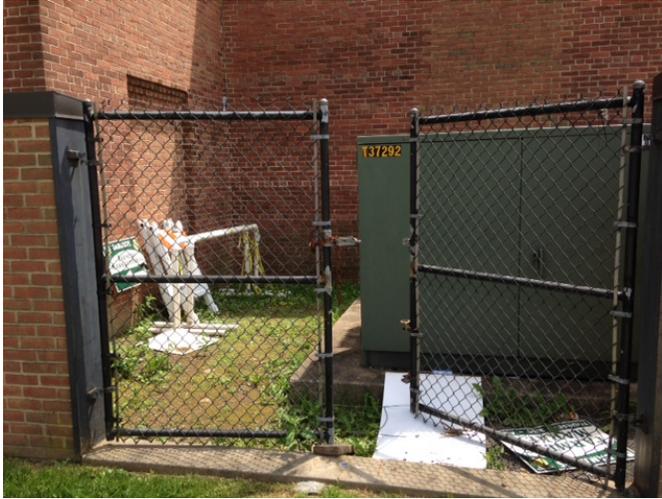
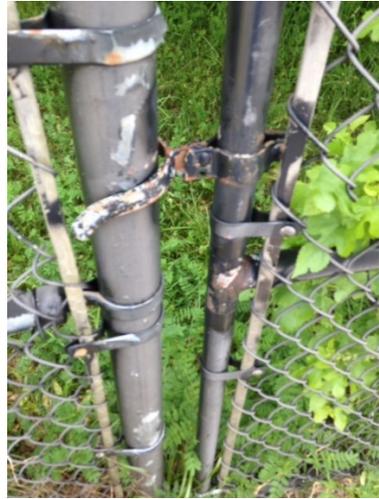
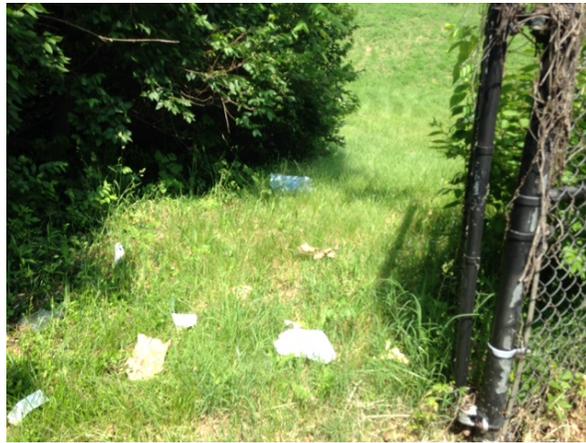
**Unsecured Gates.** The gates at the electrical box on the north side of the school, and the two gates that access the retention pond at the corner of Ridge and Bethesda Roads are unsecured.

Unsecured gates

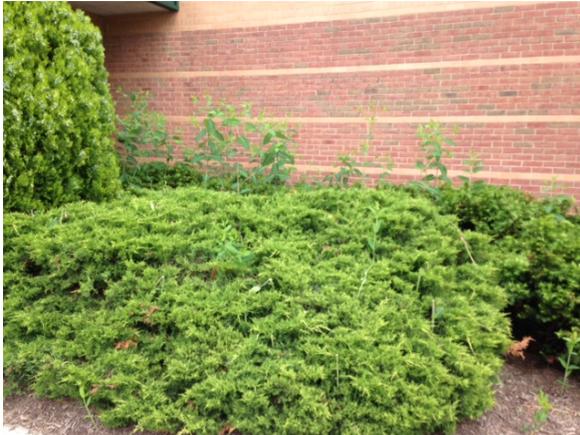
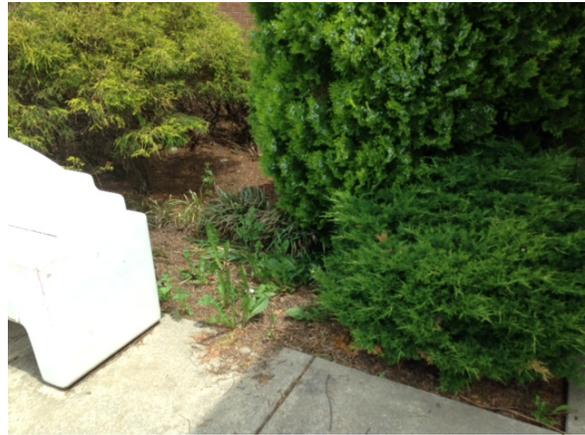
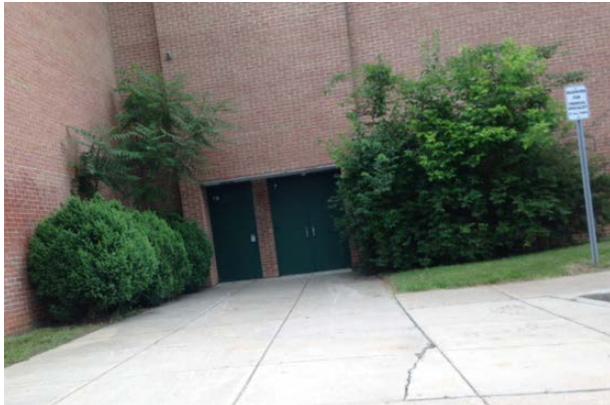
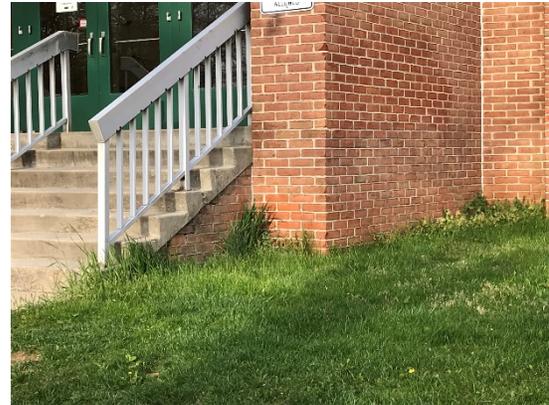
**Weeds.** There are a lot of weeds in the planting beds around the campus. There are weed trees and vines growing against and on the building, as well as covering some of the landscape plants. The presence of weeds in the beds next to the main entrance are particularly noticeable to any visitor.

Additionally, there is an overall lack of trimming following mowing and tall grass and weeds are present against the buildings, around trees, along fences and anywhere that is not mowed.

Weed trees on left. Under the vines on the right are some shrubs

Weed trimming would give the grounds a more manicured look.

1. Ensure areas are weed trimmed after mowing. This will have a very strong impact with very little effort. Keeping areas around buildings trimmed leads to a more manicured appearance. When limited

4. Remove weed trees and shrubs growing on buildings and in corners of buildings. When possible dig out roots, otherwise spot check and prune during growing season.

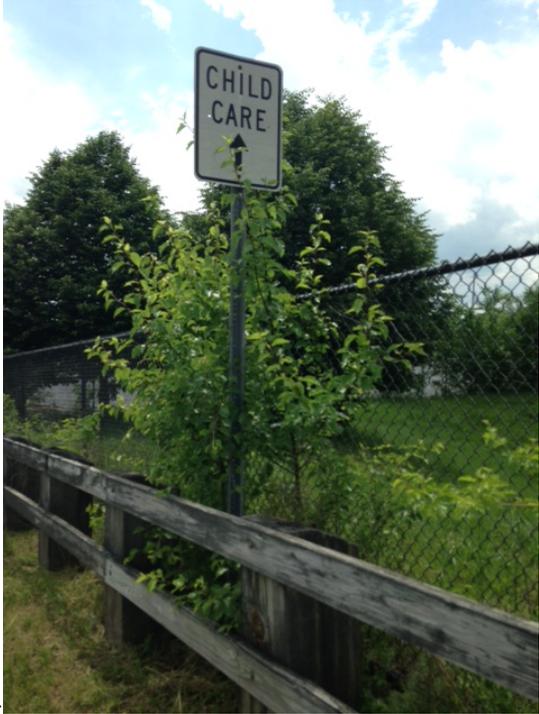
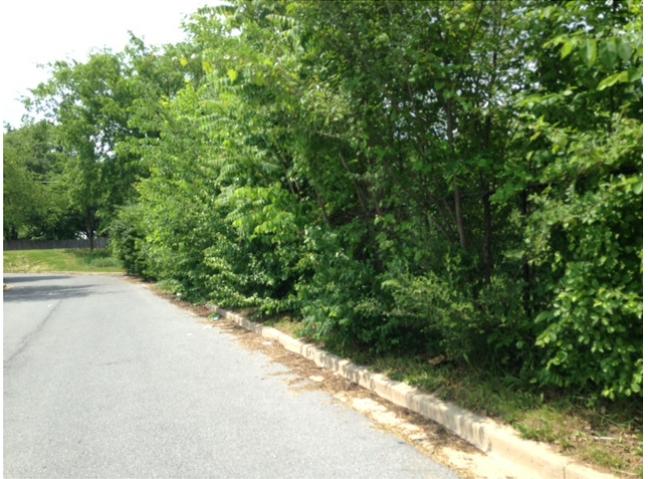
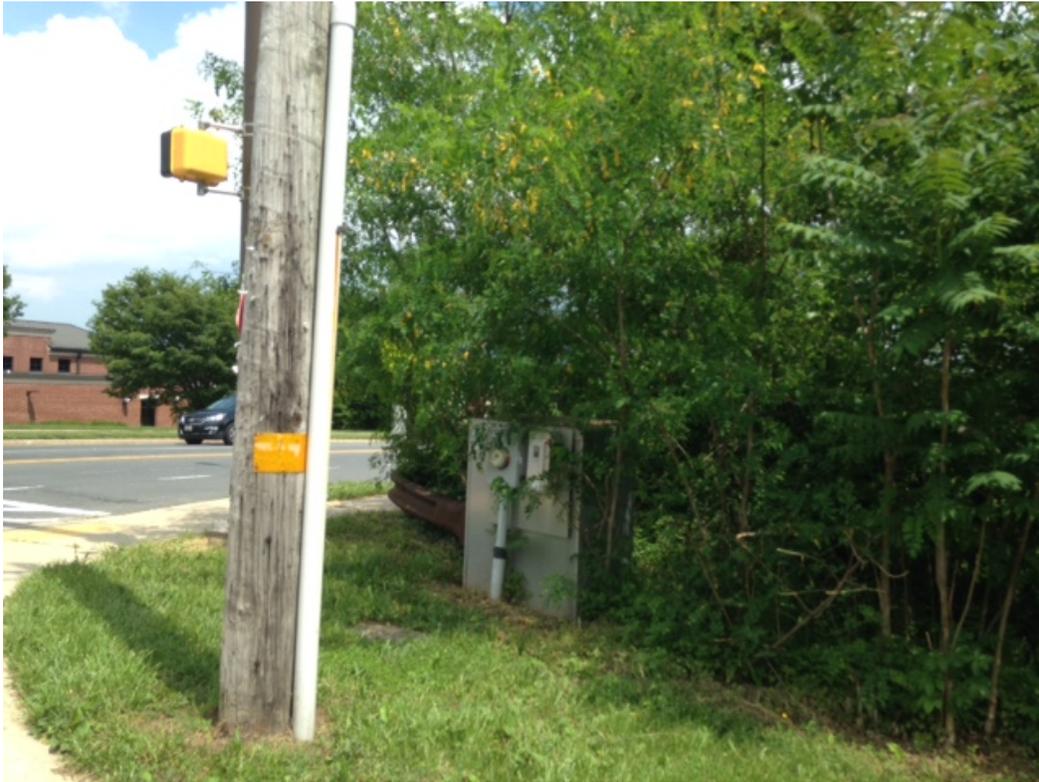
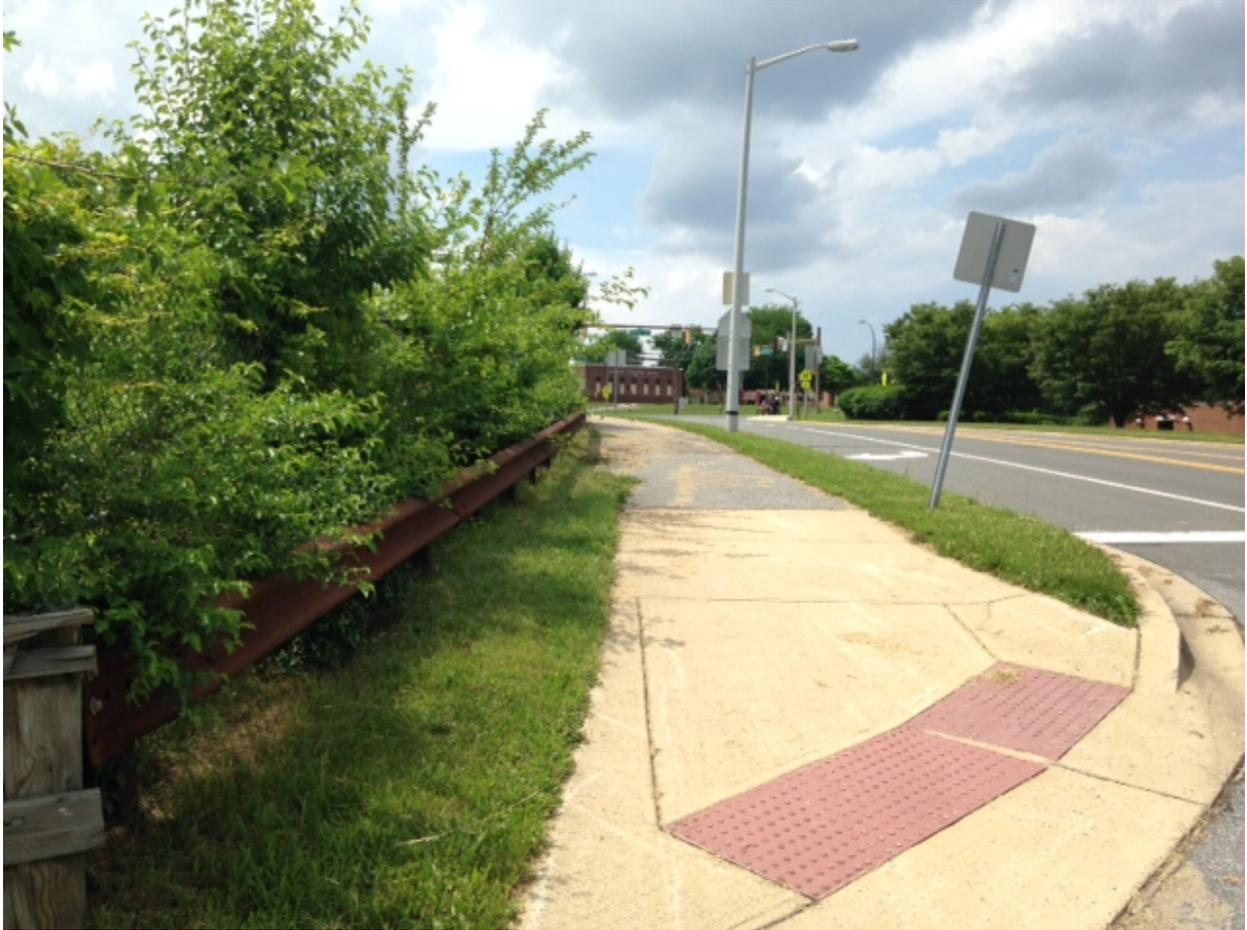
Larger, woody weeds have been allowed to proliferate along the fence lines and along the guard rails at the entrance to student parking area off of Bethesda Church road. The fence lines should be kept free of vegetation to improve aesthetics, to preserve the integrity of the fence and for security reasons. Vines and trees will damage the fence as they grow.

10. Remove vines, brush and weed trees from fence and water retention area at the corner of Ridge and Bethesda Church Road.

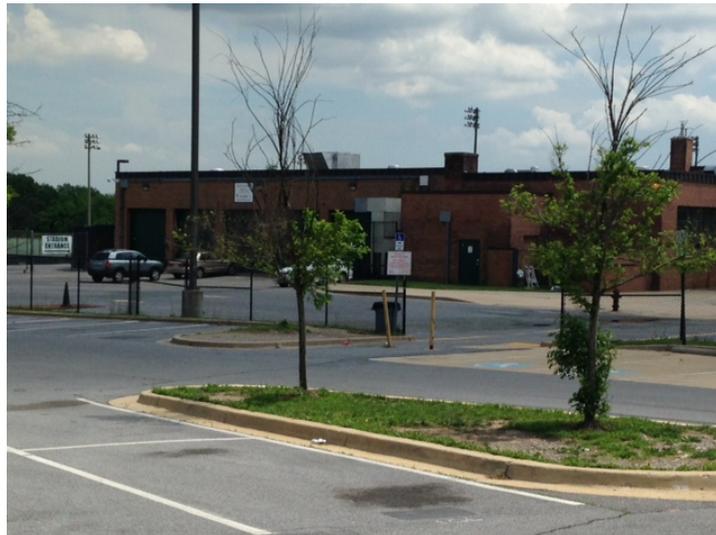
***Unhealthy Trees.*** Dead and dying trees should be removed as soon as possible. The unhealthy trees on the grounds are extremely unsightly. Since the Campus Beautification Committee met with DHS administration and facility maintenance staff in May, some dead trees have been removed.

12. Tree maintenance. Remove dead and dying trees and grind/ remove stumps. Refer to Appendix E, Tree Maintenance Objectives. In addition to removals, there are several trees that should be pruned for dead wood removal, crown raising and structure.

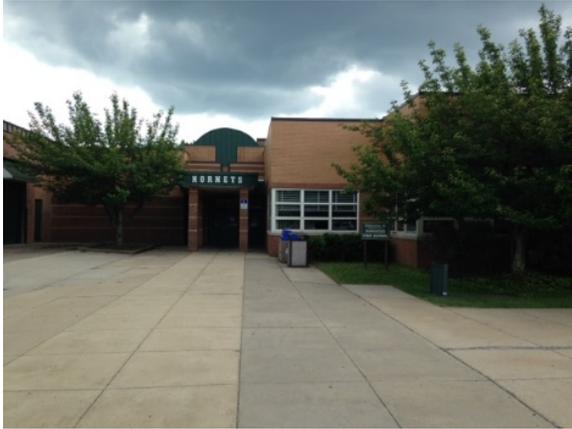
Cafeteria Entrance

The cafeteria entrance features two specimen Kwanzan flowering cherries and two hedges. The gymnasium entrance is flanked on the southside by four American hop hornbeam trees and a small yew hedge. The north side has a panel of grass. A consideration for a future project could be plantings on the north side of the gym entrance to create a balanced look.

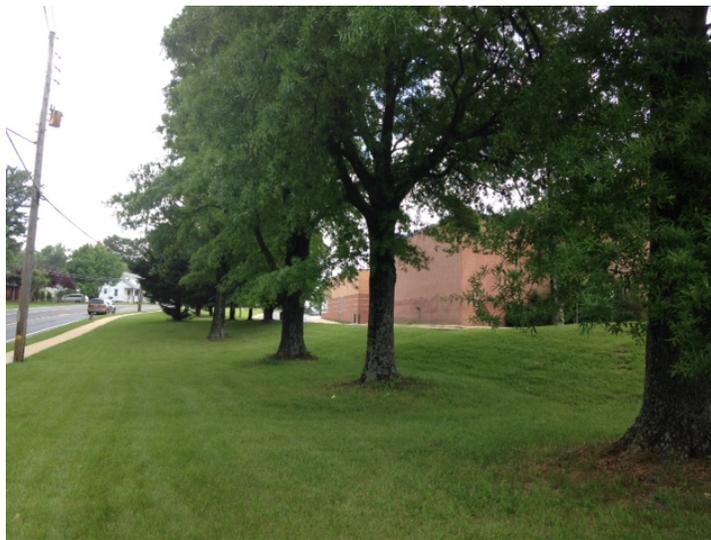
***Peripheral Areas.*** These are the areas of the campus visible to the public from the main roads and traffic areas. Similar to the idea of “curb appeal,” it is what people see as they pass by the school, or the immediate impression people get when entering one of the parking areas off of Ridge or Bethesda Church Road. Ridge Road features the two DHS signs and plantings around the PTSA sign. Another strong landscape feature along Ridge Road are the 4 large willow oaks previously mentioned.

Trees and grass along Ridge Road

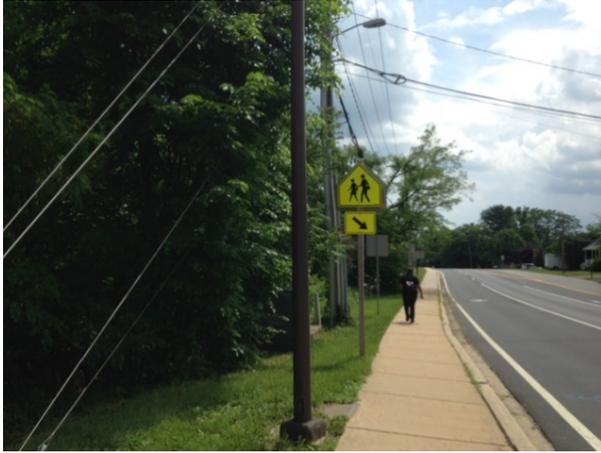
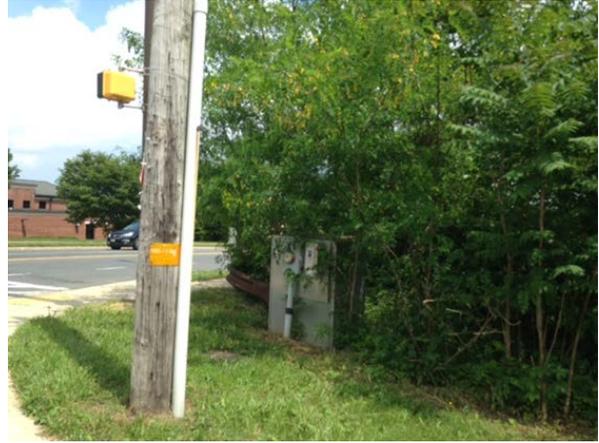
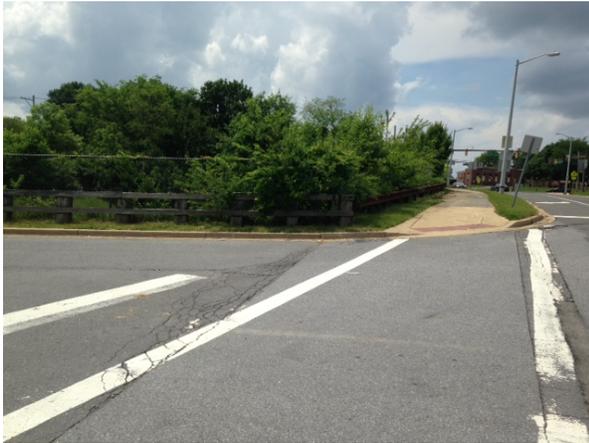
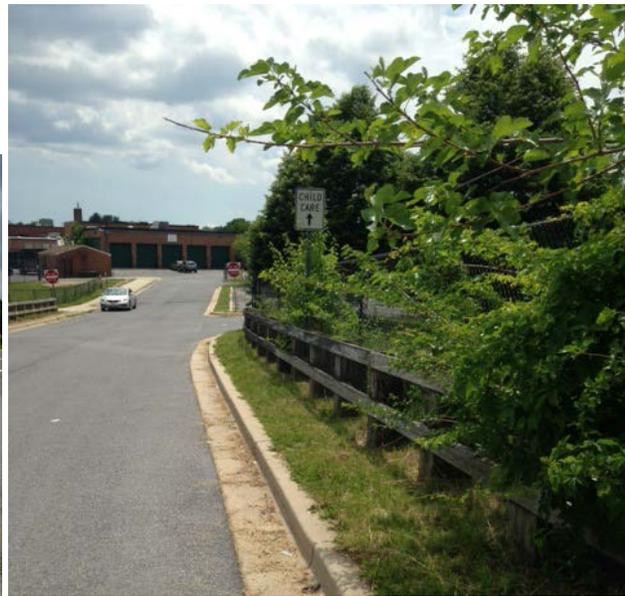
The north west portion of the campus around the water retention area, student parking area and along Bethesda Church Road is very contrasting to the more manicured looking southern portion of Ridge Road. Weed trees, vines and brush block the view to the school and the school appears completely unkept. Removal and management of the weeds will open views of the school and some of the large and more desirable trees within the retention area.

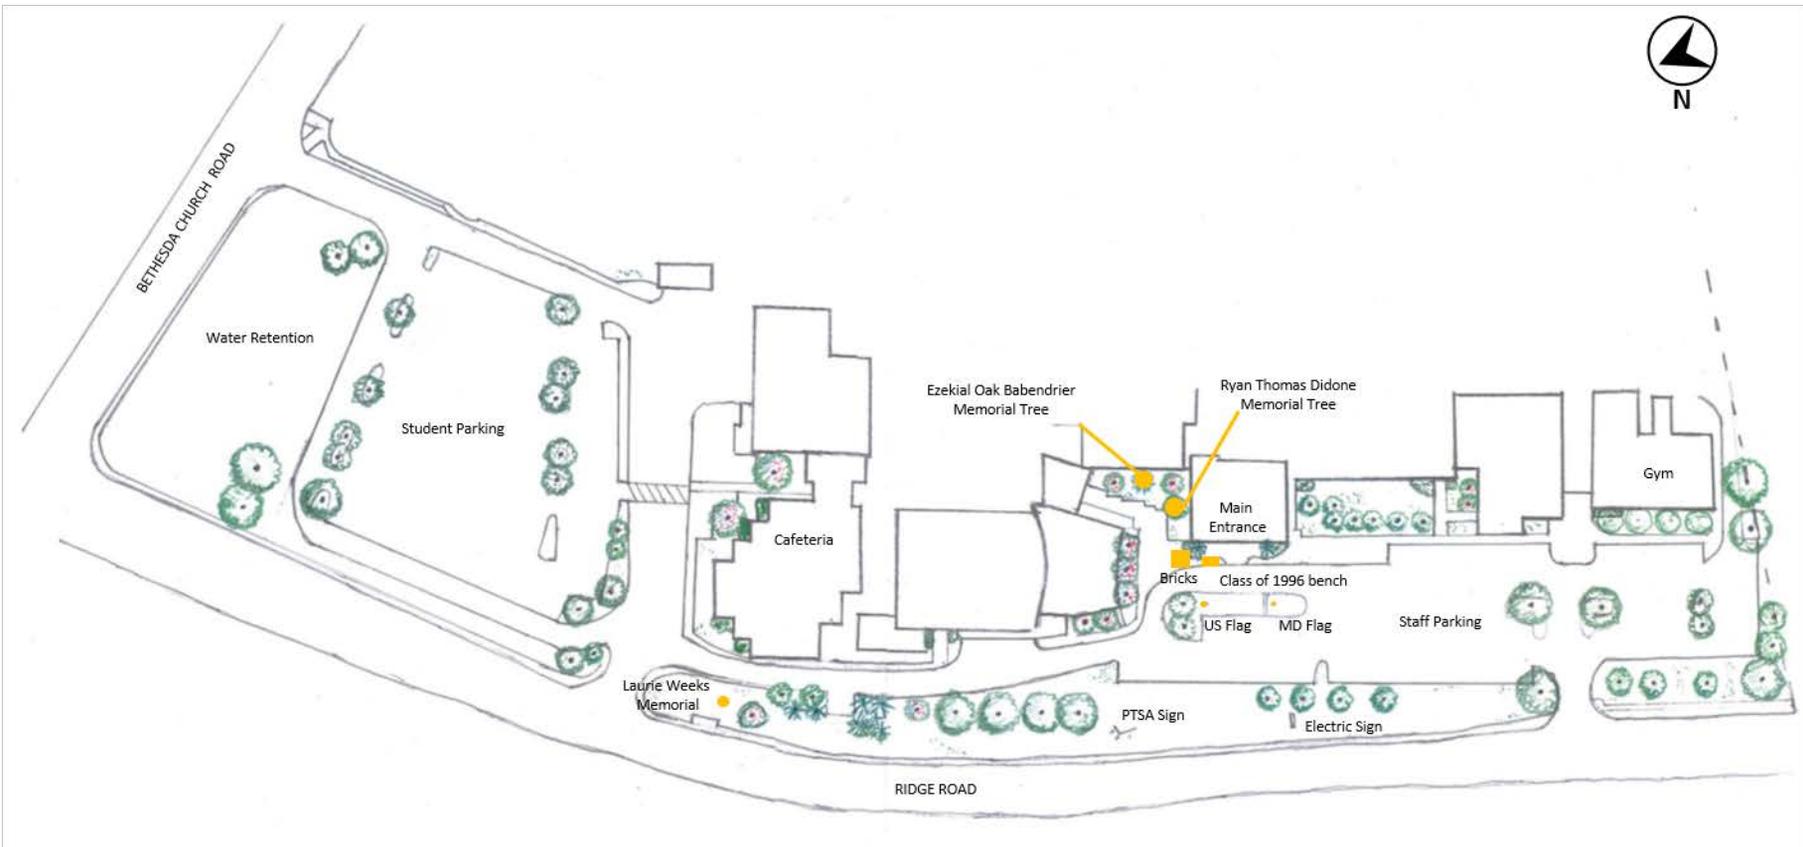
## DAMASCUS HIGH SCHOOL LANDSCAPE SITE PLAN

The landscape site plan (Appendix A) shows the existing trees, plants and other features. For purposes of this plan, only the western side of the school campus is shown. Cultural resources are highlighted. The rest of the campus will be surveyed at a later date.

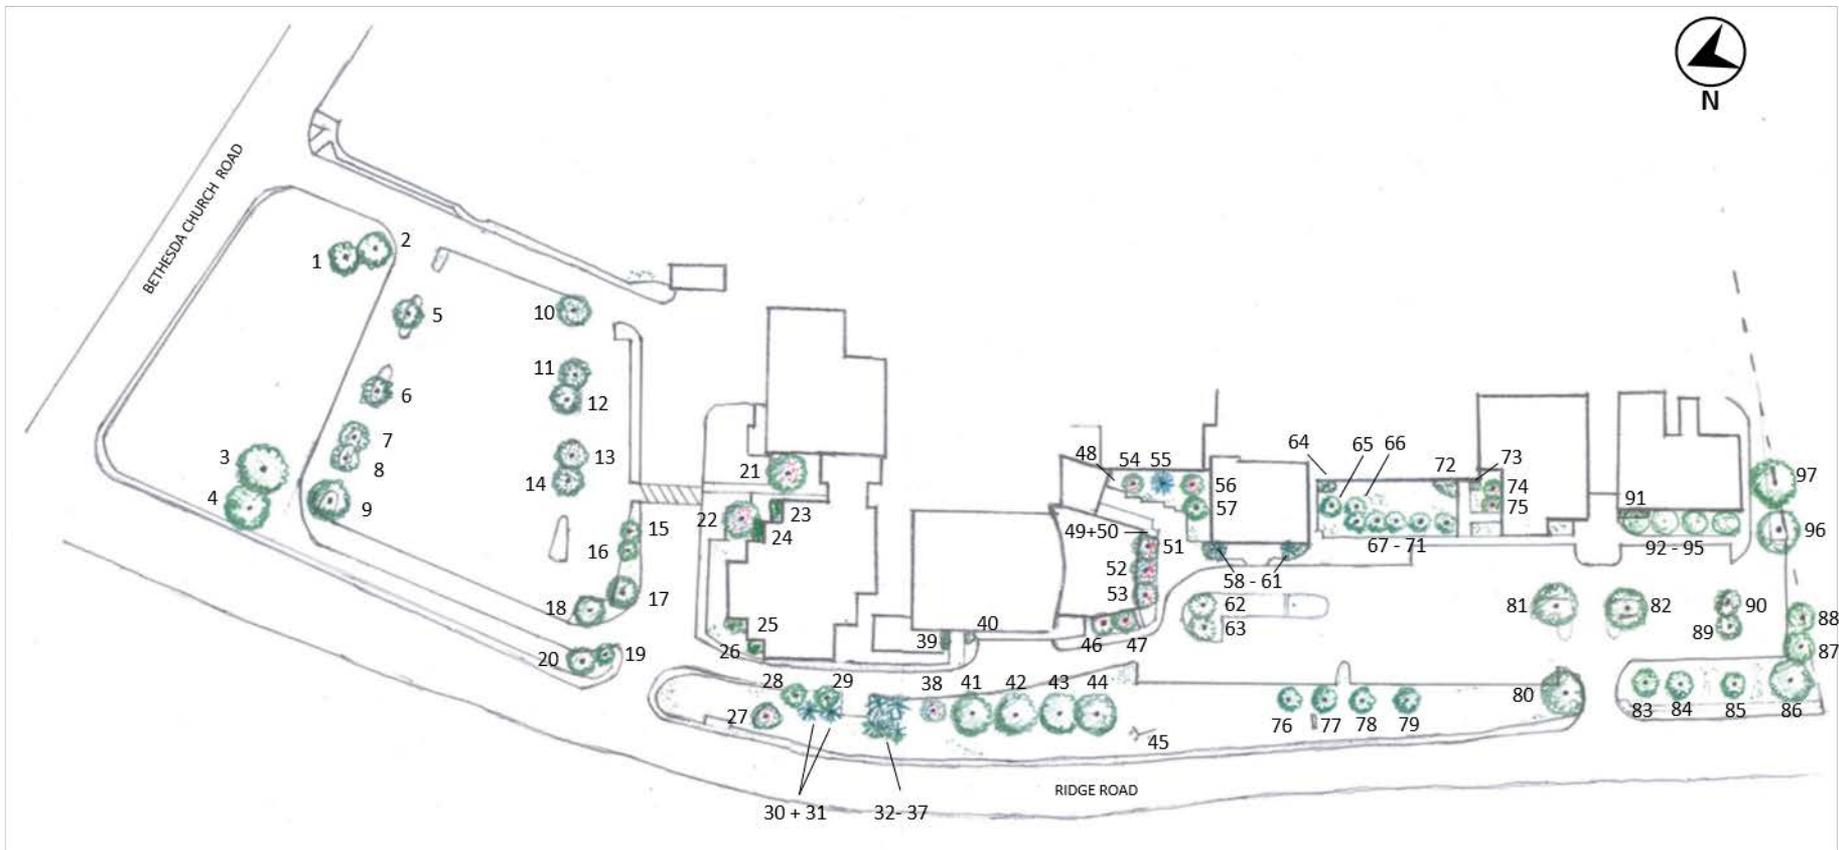
**DAMASCUS HIGH SCHOOL**  
**Tree and Plant Survey**

Existing trees, shrubs and planting areas are identified on the Tree and Plant Survey Sheet (Appendix B). Each tree, shrub and planting area is labelled with a number that corresponds to the plant number in the table of trees and plants. The survey was conducted between May and August 2018.

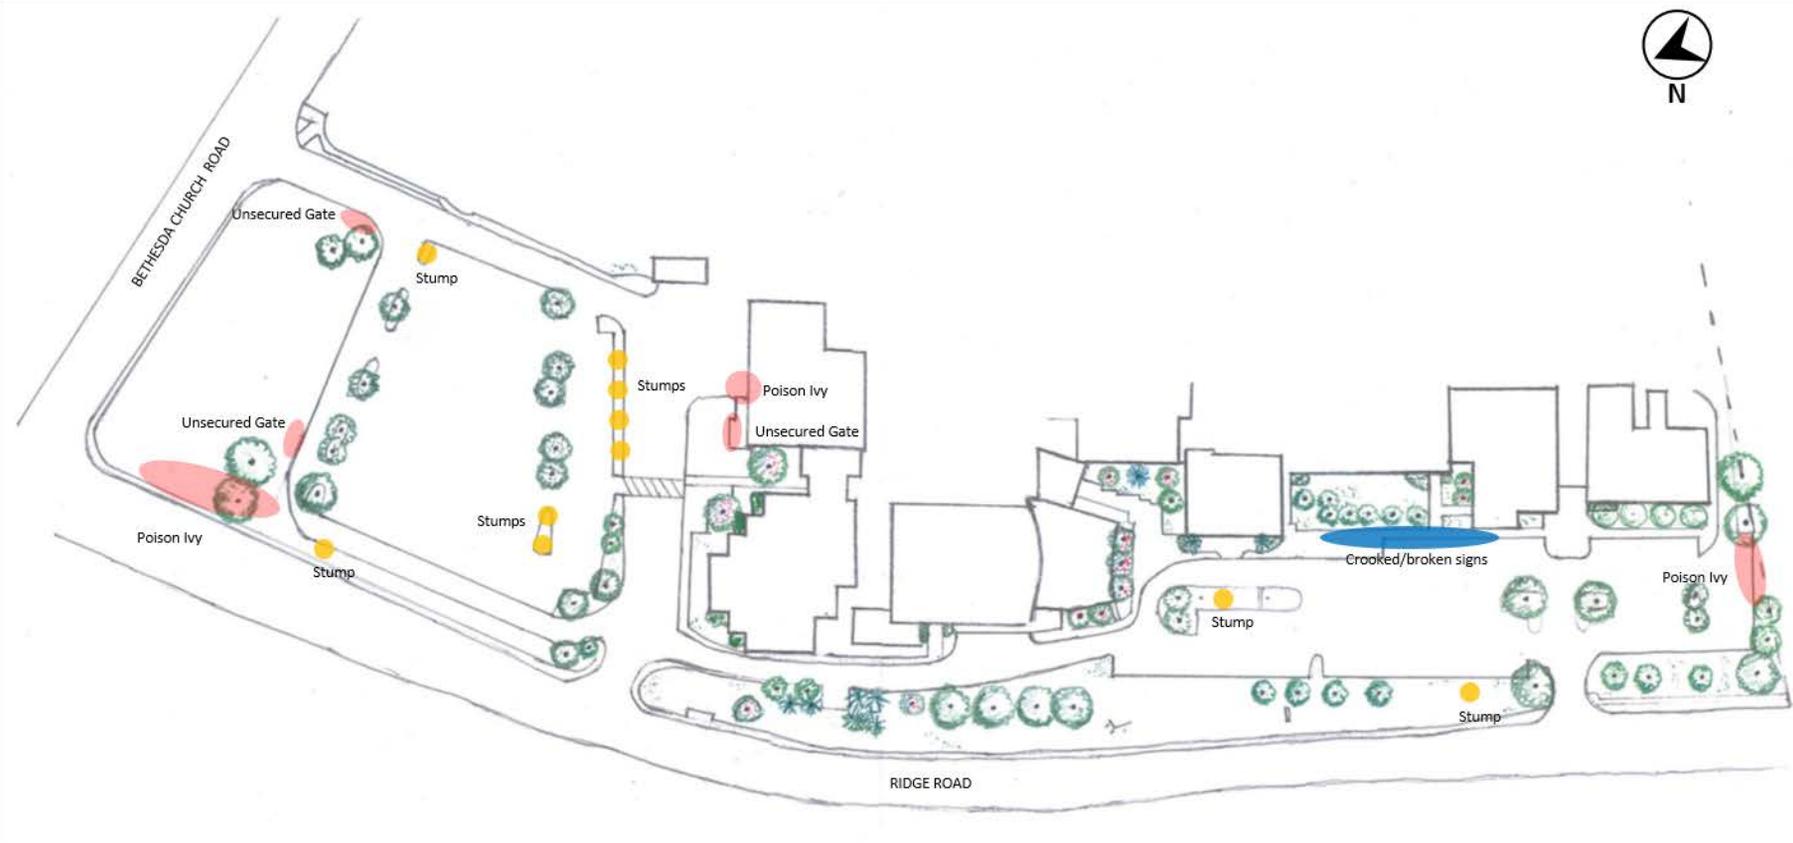
**DAMASCUS HIGH SCHOOL**  
**Areas of Concern**

Areas of high concern are highlighted on the sheet Areas of Concern (Appendix C).

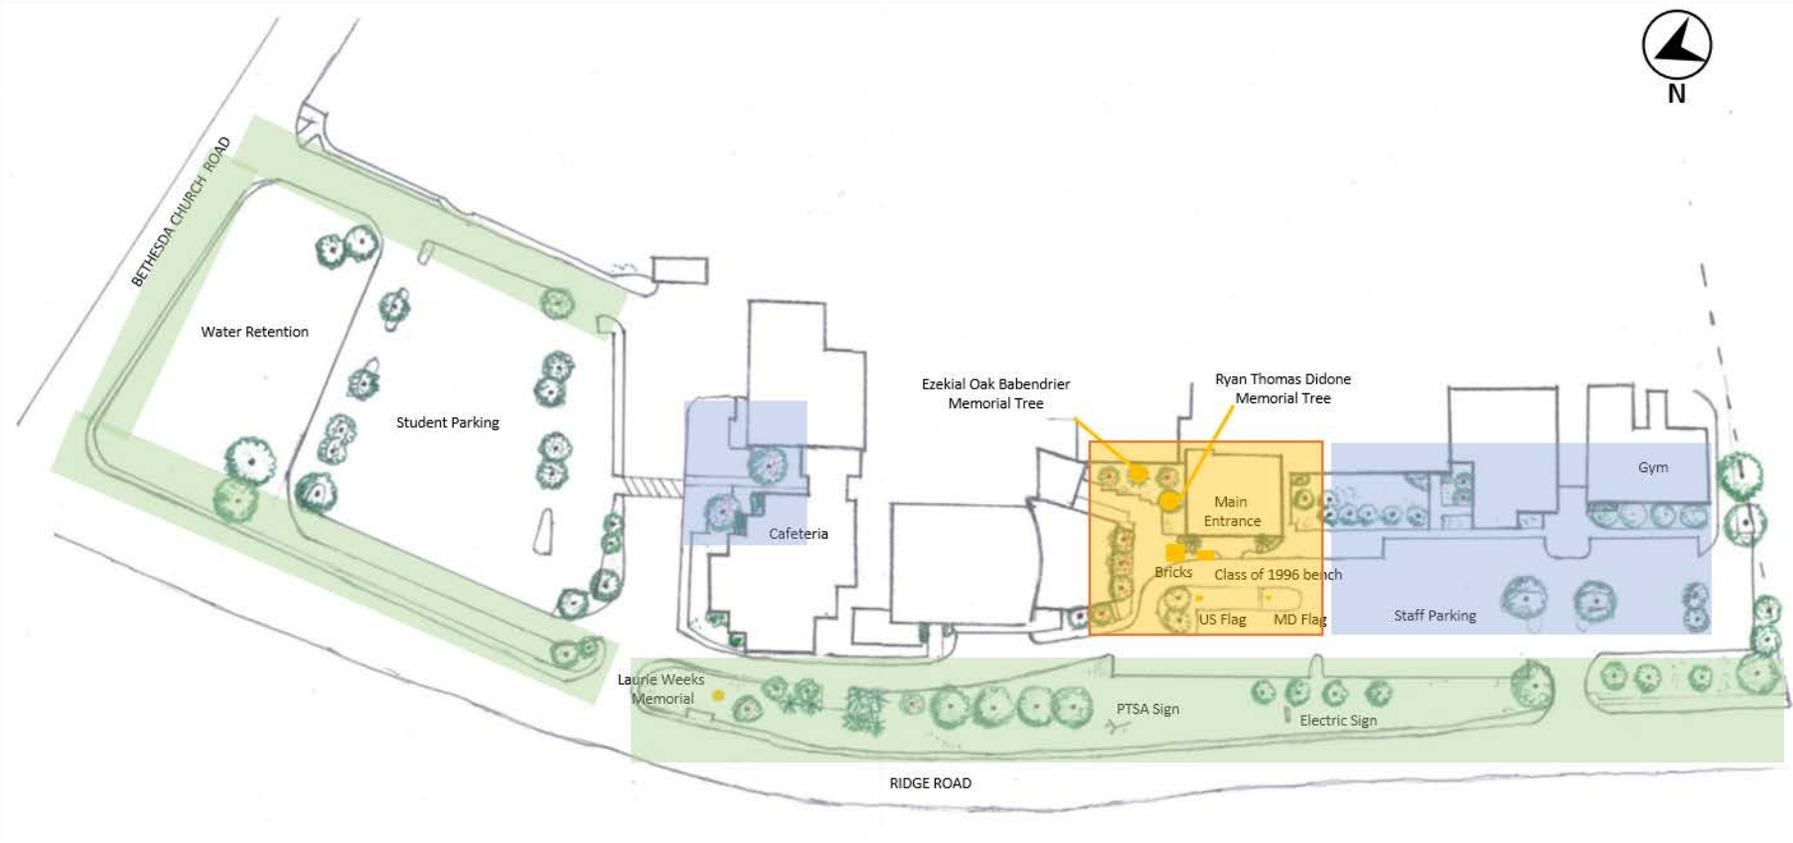
## DAMASCUS HIGH SCHOOL Priority Areas

The sheet entitled Priority Areas (Appendix D) proposes an approach that establishes 4 Management Areas. Grounds maintenance tasks should be prioritized based on available resources and impact the effort has on the appearance of the grounds.
